TJ GREEN ASSOCIATES, LLC

# MIL STD 883 TM 2017 Certification Test

## Student Assessment

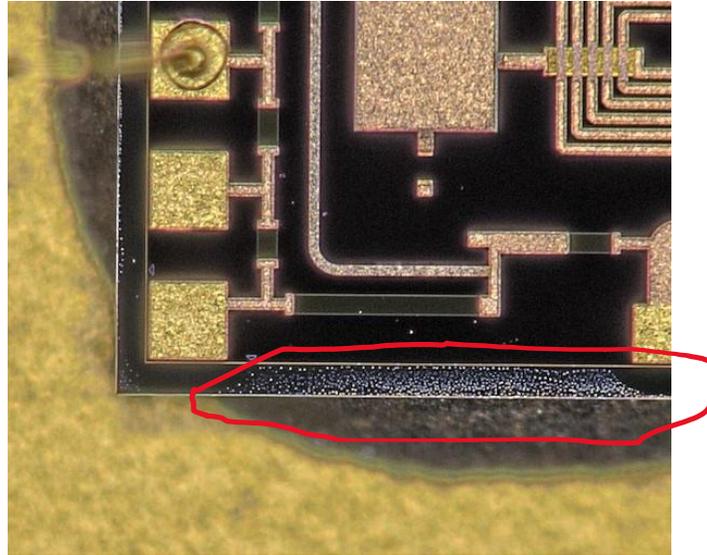
1. ACCEPT  REJECT  (Circle one and briefly explain why below.)

REASON: Resin bleed out wicked up onto MMIC

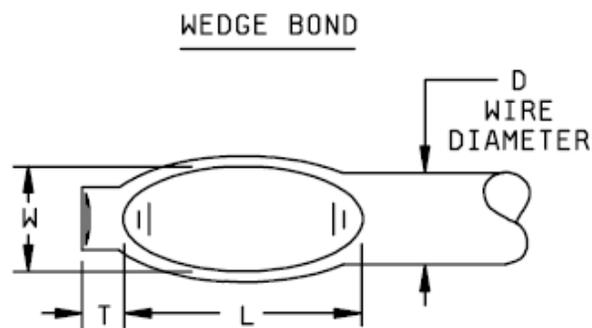
2. The maximum deformation on a thermosonic wedge bond (W) per TM 2017 is:

- A. 1.5 X the wire diameter  
B. 3.0 X the wire diameter  
 C. 2.0 X the wire diameter  
D. None of the above

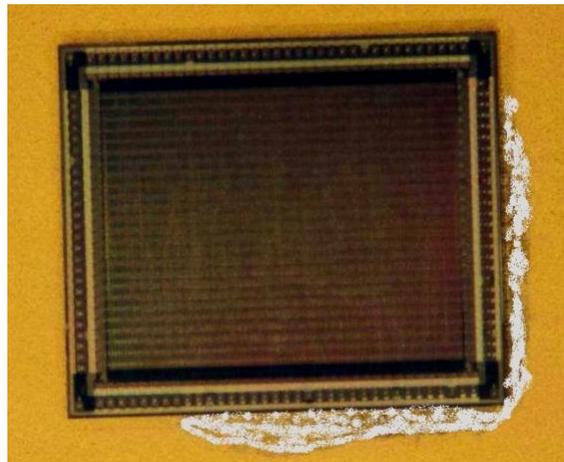
3. Below is a photo of a silicon die with silver epoxy die attach material visible at the perimeter. Choose the following:

- A. ACCEPT: Epoxy visible around 50% of the perimeter
- B. REJECT: Too much epoxy visible
- C. REJECT: Insufficient die attach material visible
- D. ACCEPT: Epoxy visible on two non-adjacent sides

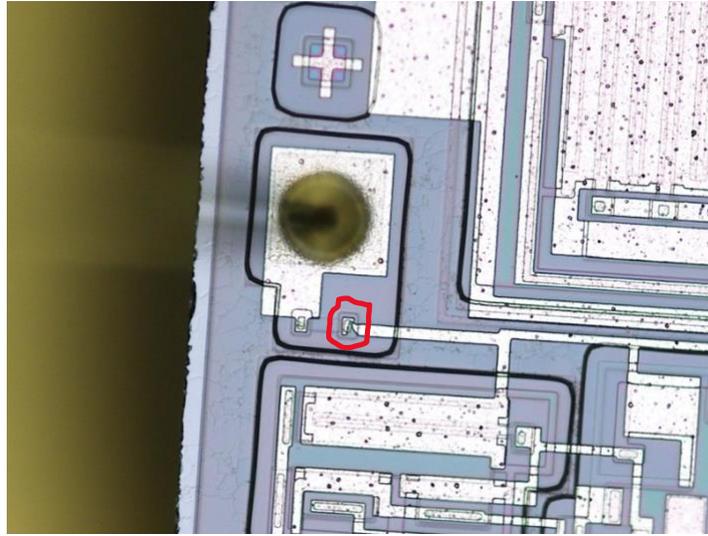
5. ACCEPT

METAL REDUCED 90% AT TOP OF VIA

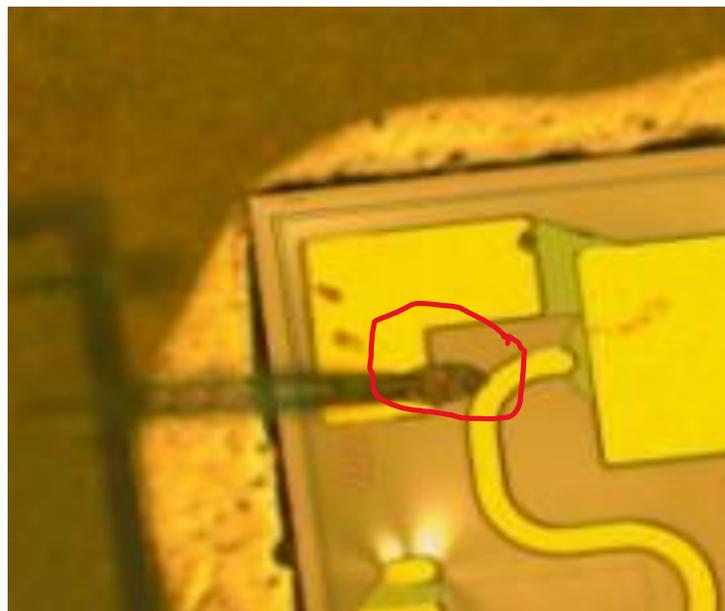
6. ACCEPT

Wedge bond more than 50% off pad and shorted.

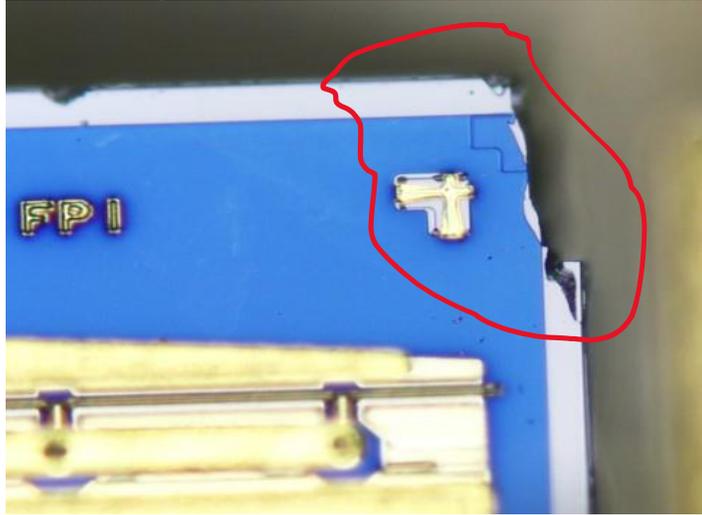
7. ACCEPT REJECT (Circle one and briefly explain why below.)

Corner chipout OK not into active metal

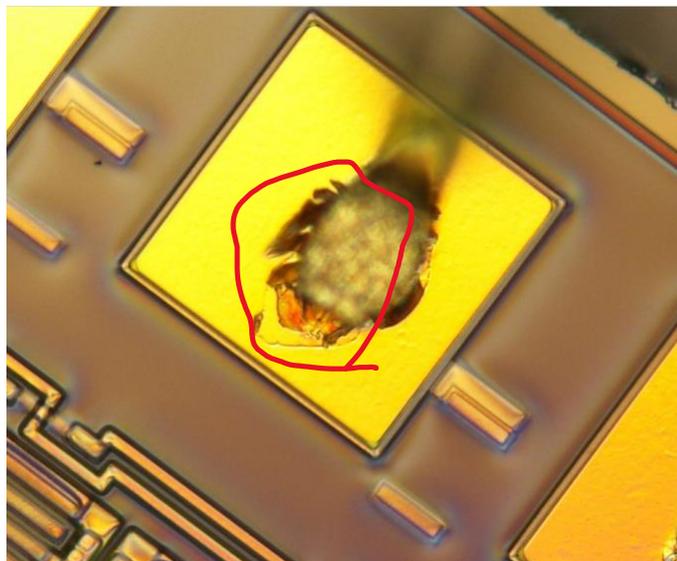
8. ACCEPT REJECT (Circle one and briefly explain why below.)

REASON: Wirebond on top of disturbed metal and bond pad crater.

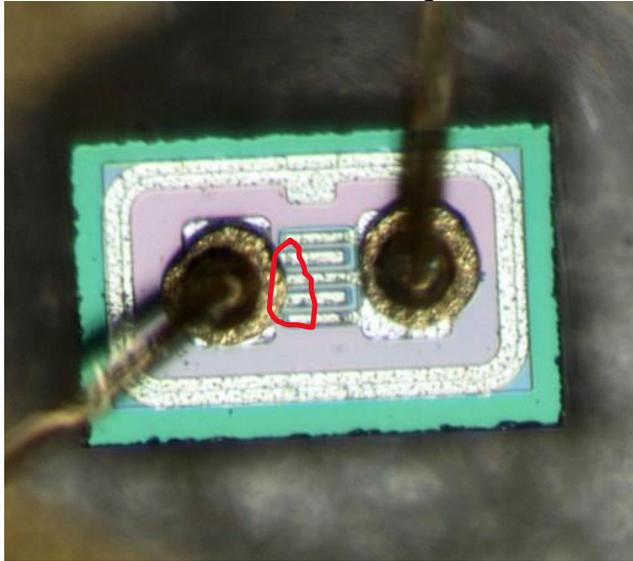
9. ACCEPT  REJECT (Circle one and briefly explain why below.)

Gold ball bond shorted to finger caused a shorted junction.

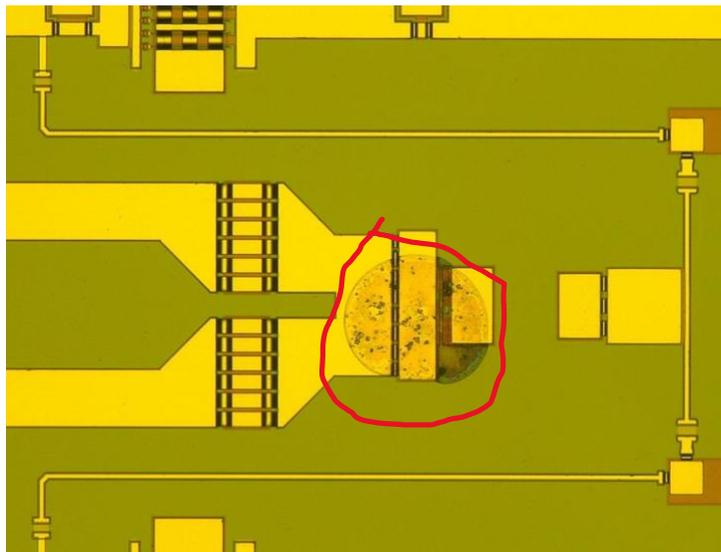
10. ACCEPT  REJECT (Circle one and briefly explain why below.)

REASON: Human contamination or "spittle "

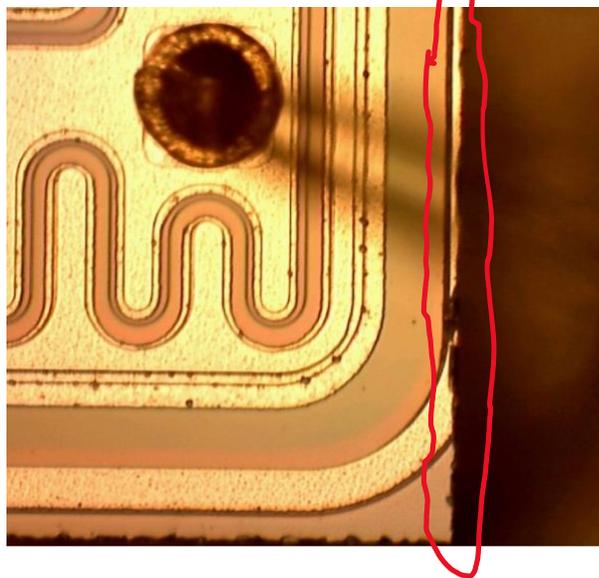
11. ACCEPT

A poorly aligned wafer saw cut on RHS cut through guard ring.

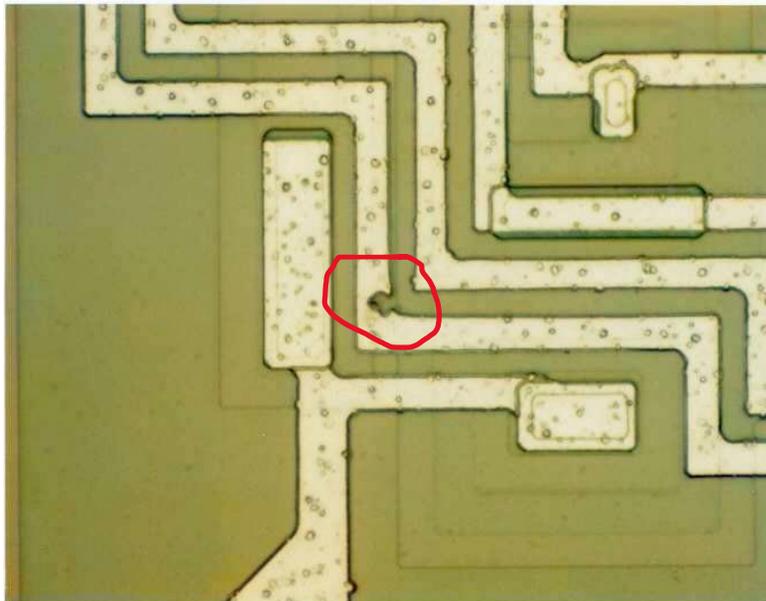
12. ACCEPT

REASON: A void in metal run greater than 50%
