# Course Notes

## Pre Cap Visual Inspection

MIL-STD-883 TM 2017

Virtual Training  
December 14-17, 2020

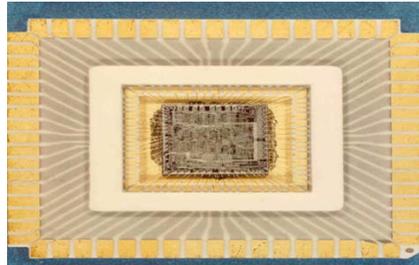
Single IC Chip in 32 Pin Cerdip

INSPECT PER TM 2010

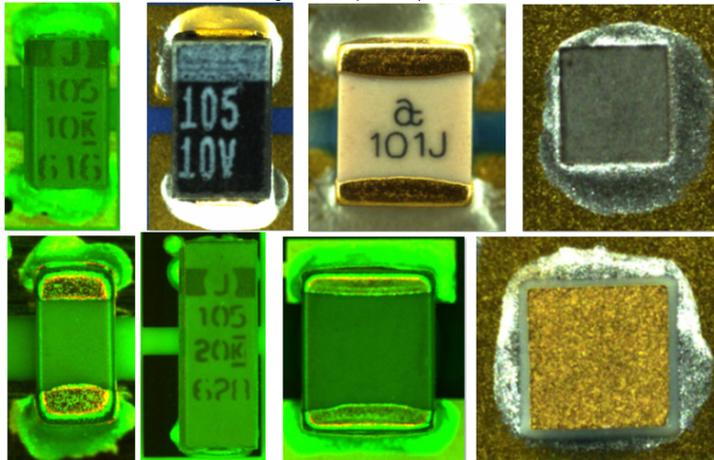
Capacitors are passive elements that store electrical energy. They come in a variety of shapes and sizes and the unit of measure is a Farad symbol F. Inspection criteria for these types of devices is found in TM 2032 para. 3.3. However, the epoxy attach criteria is found in TM 2017.

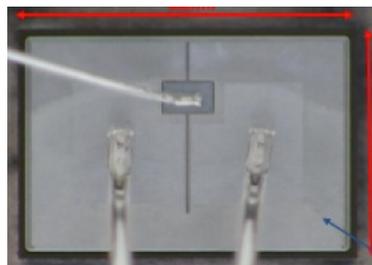
MOSFET in a TO 3 Package

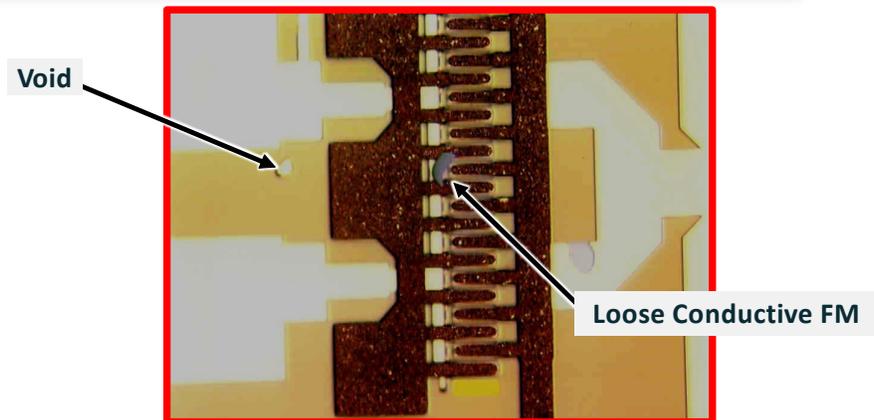
An opaque foreign material particle appears to be bridging the active circuit region. Opaque particles are generally considered conductive and may potentially cause a short within the device. Per TM 2017, a light touch with a probe or 20 PSIG N2 blow off is used to verify attachment.

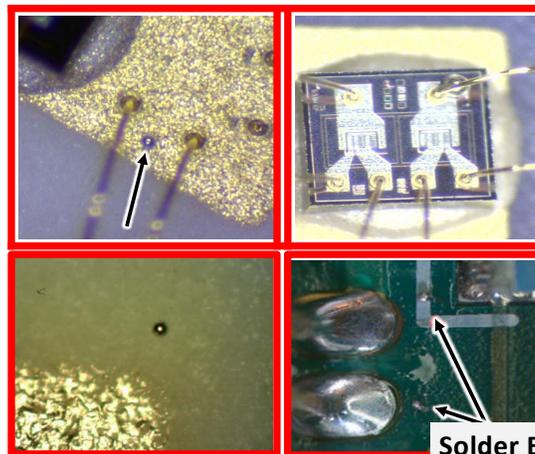
Balling of the eutectic or solder mount material that does not exhibit a minimum of 50 percent peripheral fillet . Solder balls may break loose and cause a short circuit within the device.

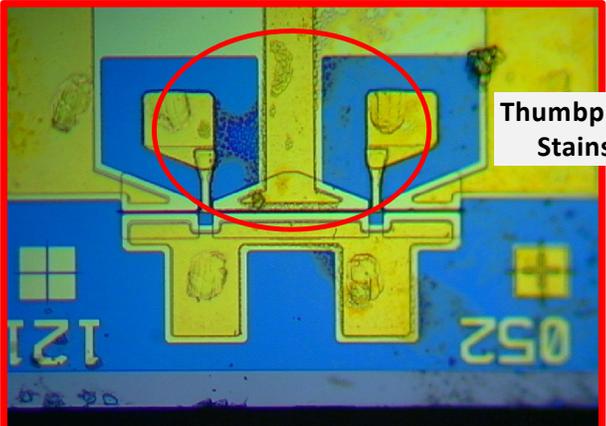
Thumbprint Stains

Finger oils and grease on the FET may degrade the electrical functioning of the device and interfere with the wirebonding process.

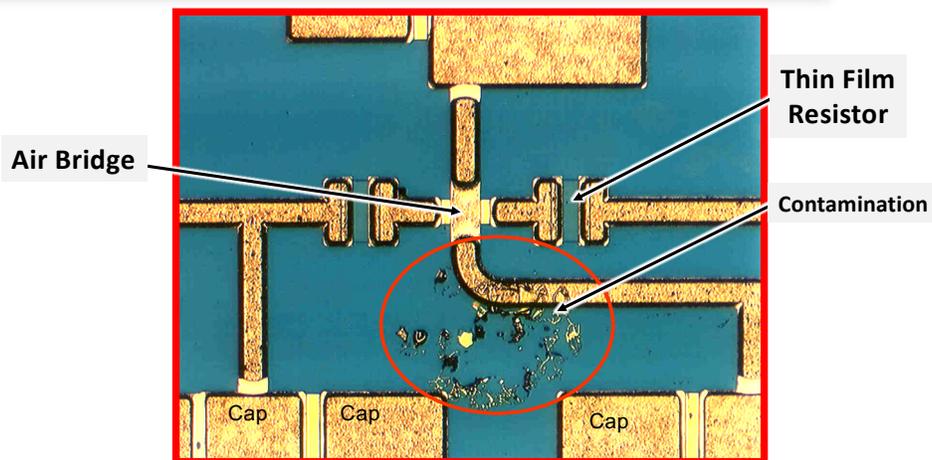
NOTES: The process contamination was determined to originate from the wafer fab process, excess metal that was not properly etched back, may cause shorting. (100X)

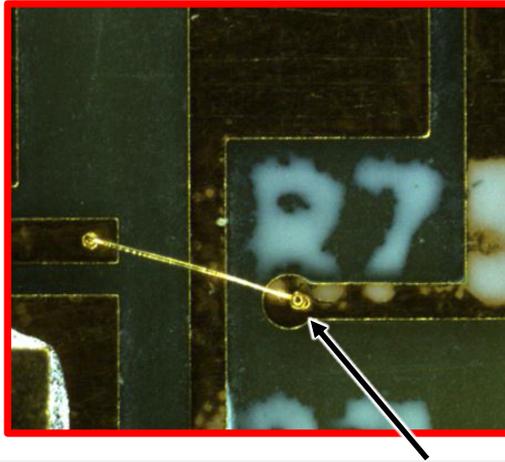
Wirebonds placed on contaminated foreign material will likely detach and fail in service. The bond pads have to be very clean in order for the gold wire to stick.

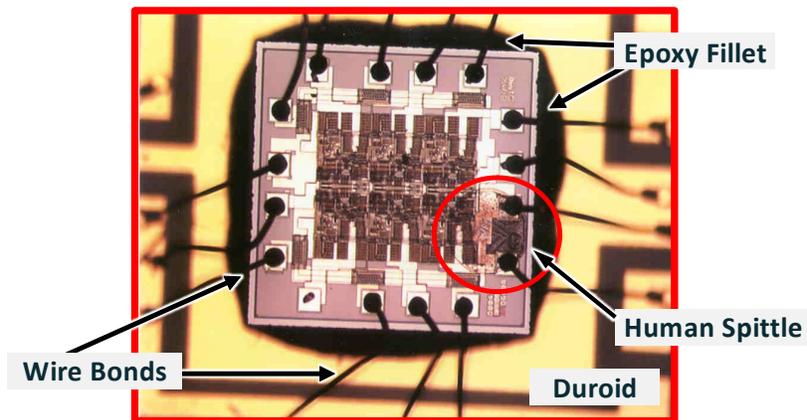
Human contamination in and around exposed aluminum metal on bond pad. If not cleaned properly, the potential exists for shorting and corrosion at the wirebond pad sites. (200X)

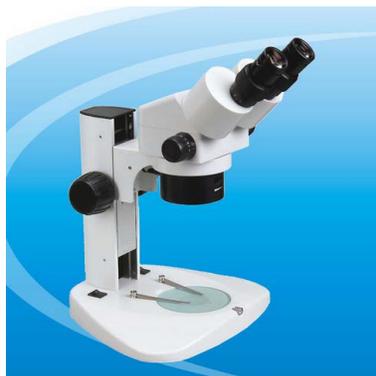
**Stereo Zoom Microscope**

Inspect for die attach, wire and ribbon bond, F/M and assembly related defects. Must be able to handle and freely rotate the part under the microscope.

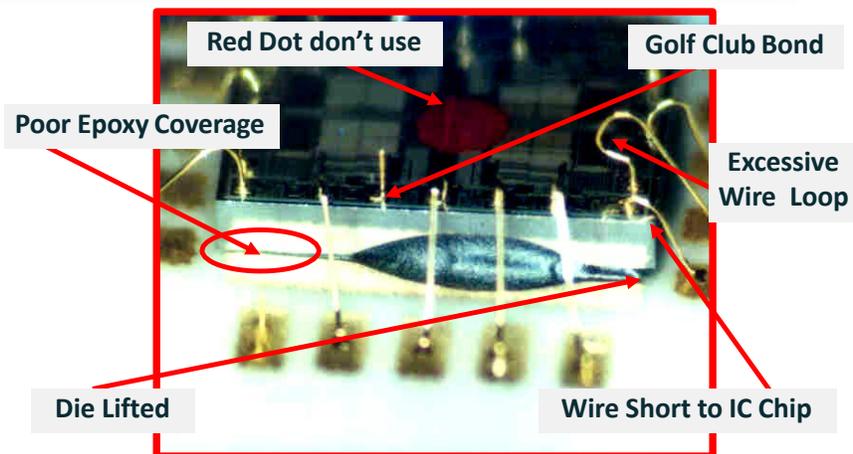
Photo showing multiple assembly related defects. The purpose of low mag stereo zoom inspection is to weed out defects related to die attach, wirebond and FM. (50X)

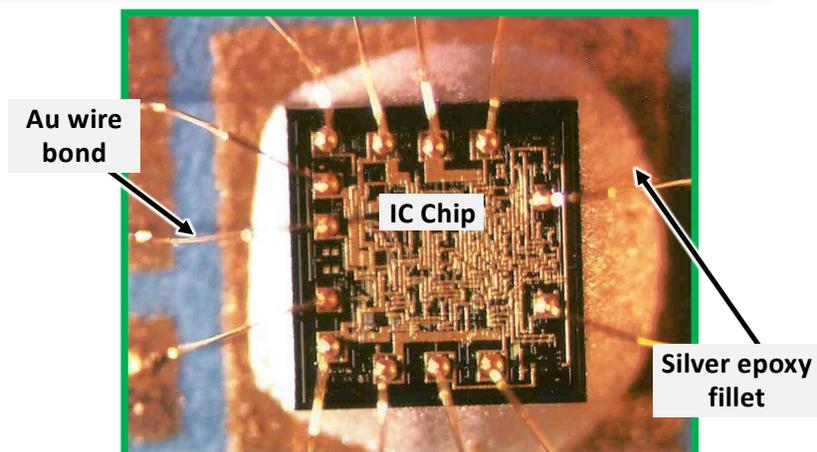
Preferred condition, IC component attach with good coverage of silver epoxy fillet on all four sides. View is looking directly down on the IC.

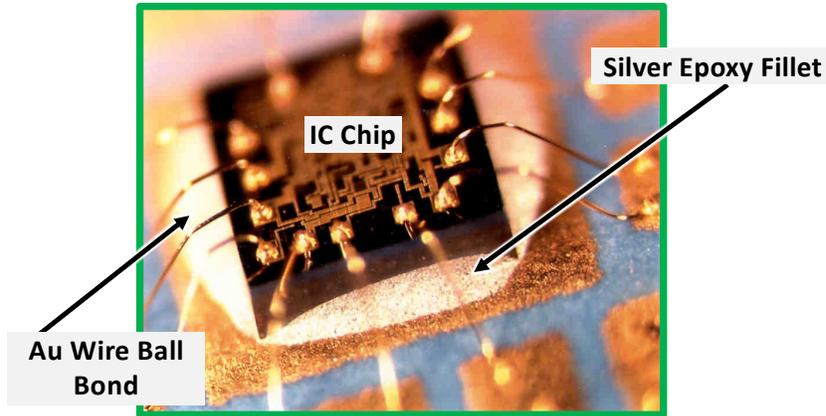
Preferred condition . . . good epoxy fillet height up the side wall of the IC chip. TM 2017 does not specify how far up the sidewall the epoxy must climb, but only that a fillet of epoxy is visible at the recommended magnification range and there should be a visible line of separation between the top of the epoxy fillet and the die surface.

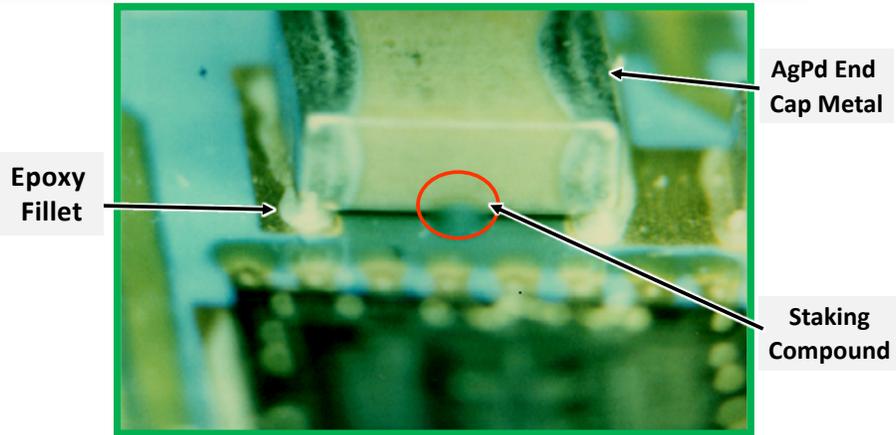
ACCEPT: Photo shows a large ceramic chip capacitor with non-conductive staking compound added to the body of the component to add strength and prevent a failure during centrifuge testing. Conductive silver epoxy is used on the end terminations. (12X)

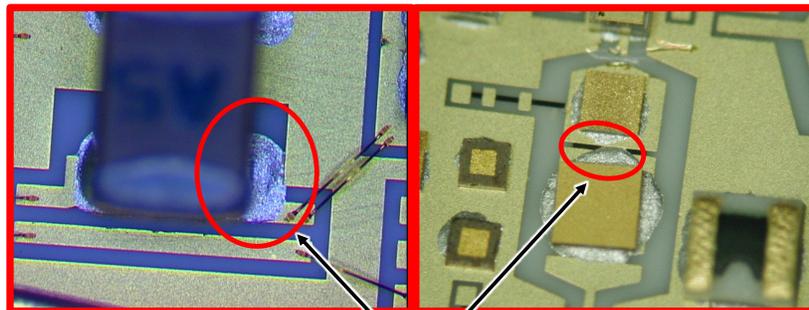
Excessive conductive silver epoxy flowed out from under the component and electrically shorted the adjacent gold traces. Parts must be removed and replaced, a time consuming and potentially damaging process. Conductive attachment adhesive or resin which comes closer than 1.0 mil to any functional metallization is a reject.

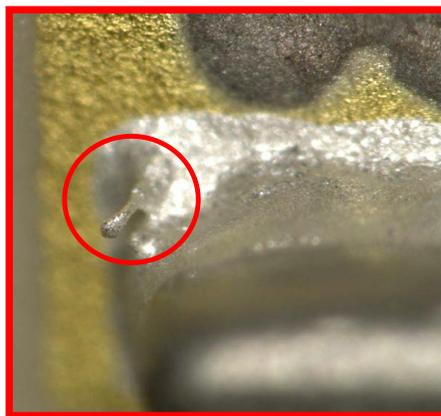
FIGURE 2017-11b. Adhesive String Criteria.

REJECT

“Stringers” of silver epoxy can break loose in operation and cause a short circuit.

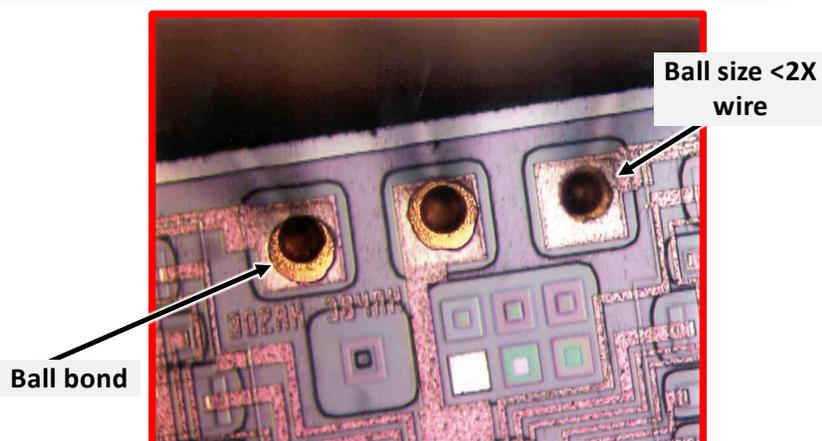
Inconsistent ball bond formation from automatic machine indicating a process problem and failure to meet spec. (50X)

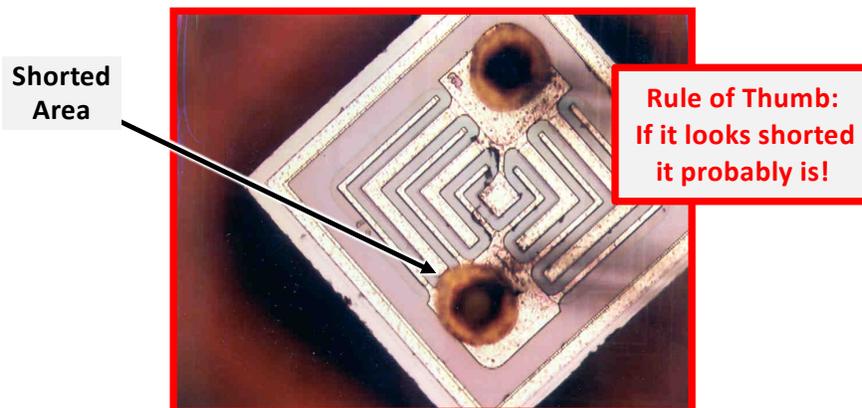
Misplaced ball bond caused a base to emitter short in the transistor structure; however, use caution when viewing straight down since the ball perimeter is wider than where it connects at the surface of the bond pad. (100X)

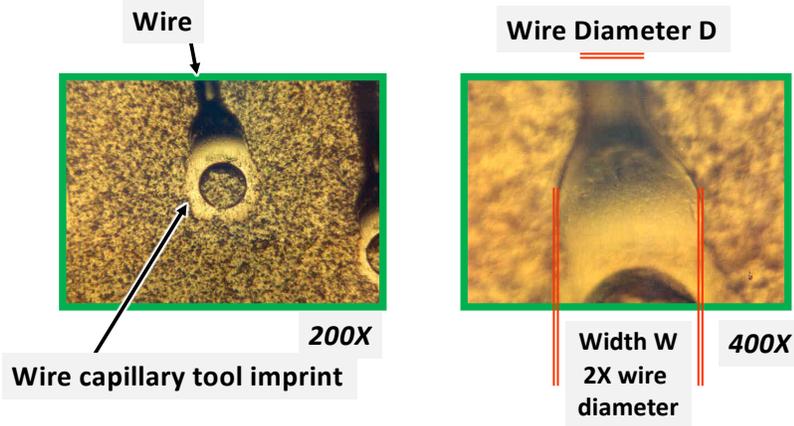
Preferred condition, view of a nicely formed 1 mil gold crescent or tailless bond, same bond at two different magnifications. Seeing a circular tool mark indicates the tool hit flat onto the surface.

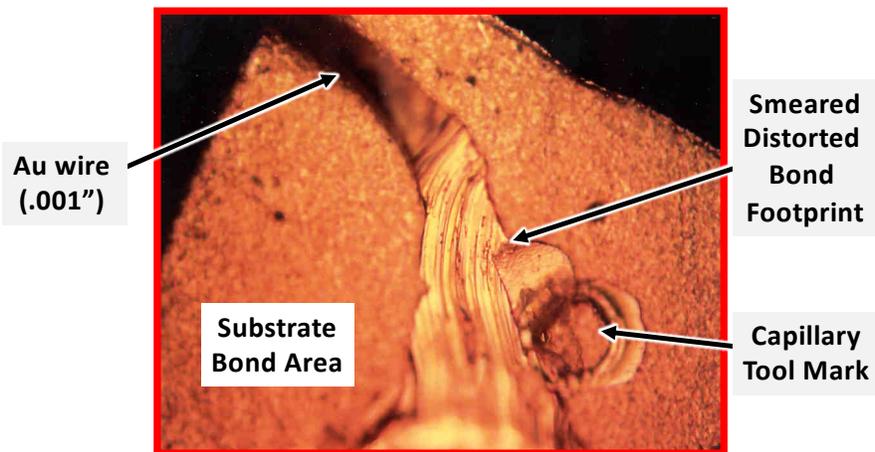
This crescent bond has a distorted/smeared footprint the result of an improperly made bond which may lift or fail with subsequent mechanical stress.

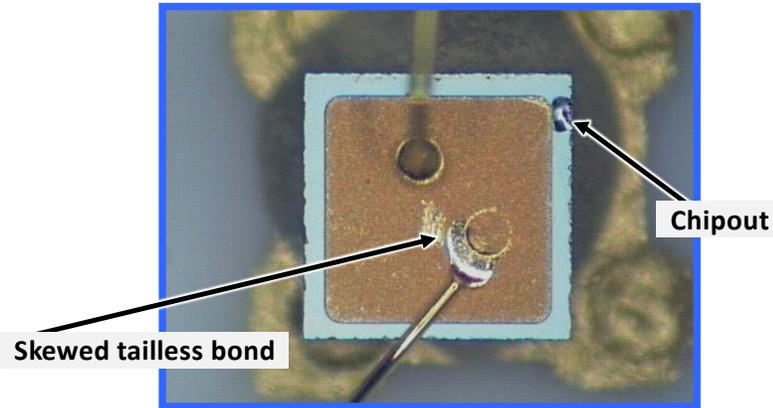
Photo above shows a bond that is skewed and skidded. This is caused by bonding in the 3 or 9 o'clock position on a manual ball bonder. These type of bonds tend to pull at lower values.

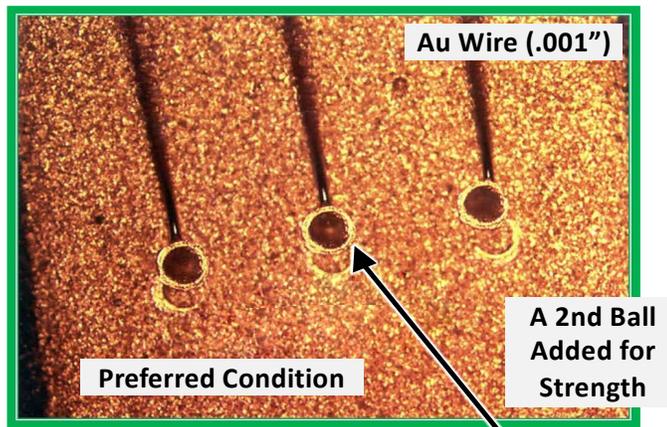
Preferred condition for a security bond. A second ball is added for strength and placed squarely on top of the crescent. Per TM 2017, second bond must cover 75 percent of the bond area of the original bottom bond. (100X)

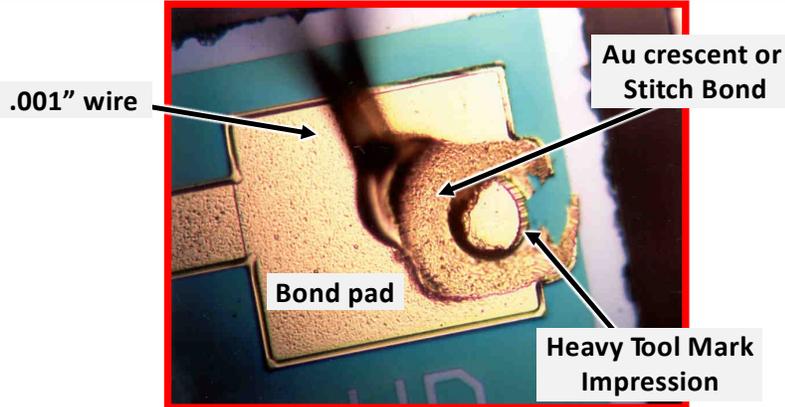
A gold crescent bond (also referred to as a tailless bond) is not allowed on an aluminum bond pad on the IC. Note in this picture the bond pad is gold, but this situation is still undesirable because the ceramic capillary contacts the fragile MMIC die and could easily cause subsurface damage/cratering.

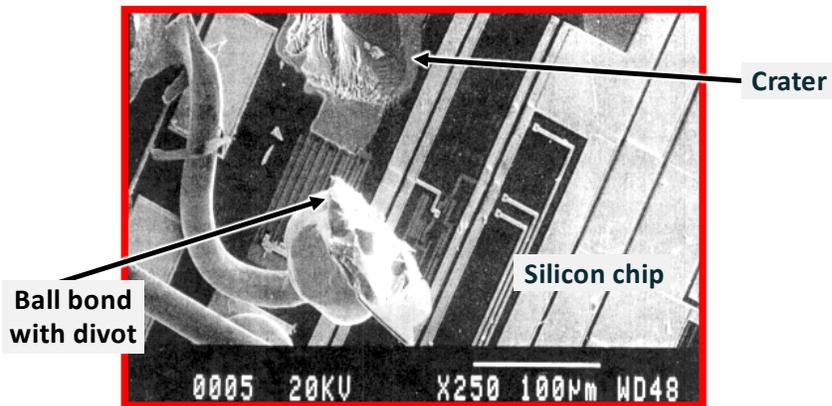
SEM photo showing gross cratering after ball shear. Optical inspection may reveal small perimeter cracking around the ball indicating the potential for cratering. MMICs and next generation GaN chips are very prone to cratering for a variety of reasons.

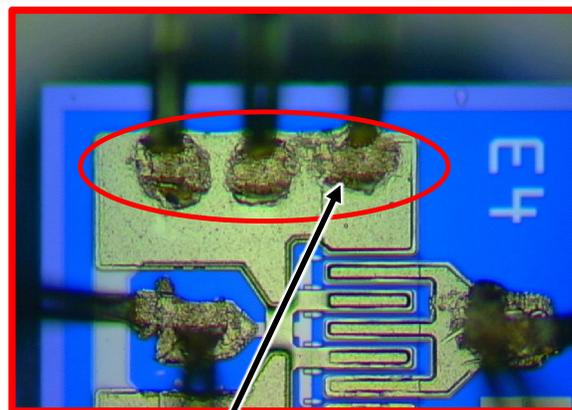
Gold wedge bonds are over deformed. Note the wires are out of focus indicating they are up in the air and no longer attached. Excessive power levels at wirebond may lead to cratering and cracking of the device.

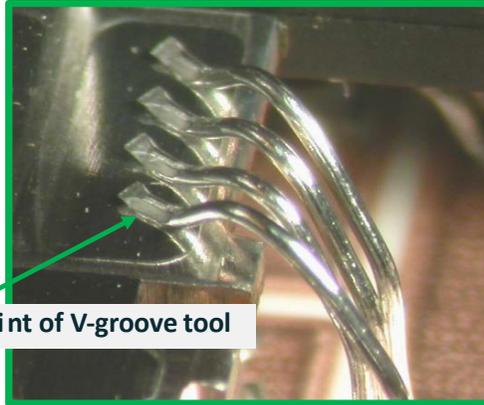
ACCEPT

Typical imprint of V-groove tool

Aluminum 8 mil wire bonded to a shelf. Note the wire impression made by the V-groove tool and cut wire tail.

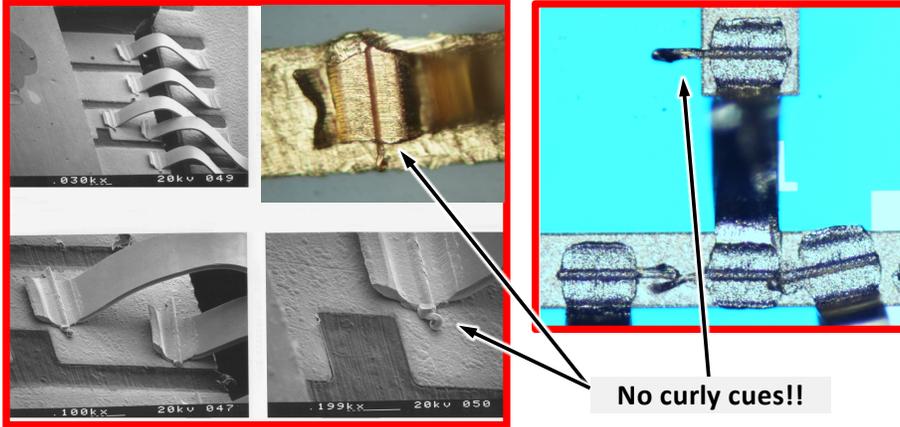
Overbonding can be a problem. Too much power/pressure can cause cracks at the junction of the bond heel as shown above. Any tears in the ribbon at the junction between the ribbon loop and bond/weld is a reject. Protruding metal from weld area may break loose.

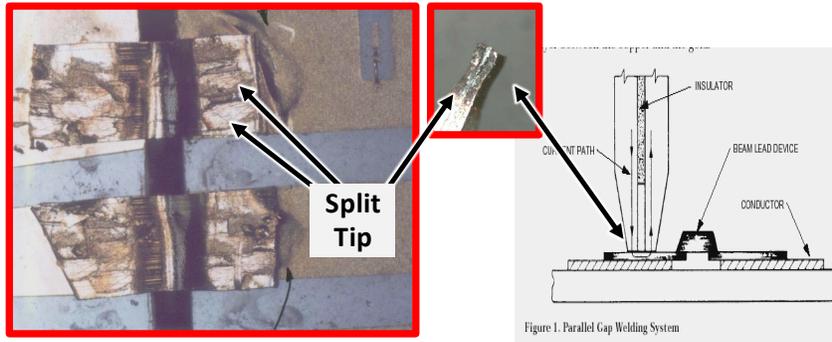
Gold ribbons attached to beam leads are sometimes “gap welded” onto the substrate. This is different than conventional ribbon bonding with ultrasonic wirebond equipment. Note the impressions from a split tip tool above. The defect above is due to the overbonding on a contaminated substrate with a dirty tip causing the metal trace to lift and peel from repeated hits.

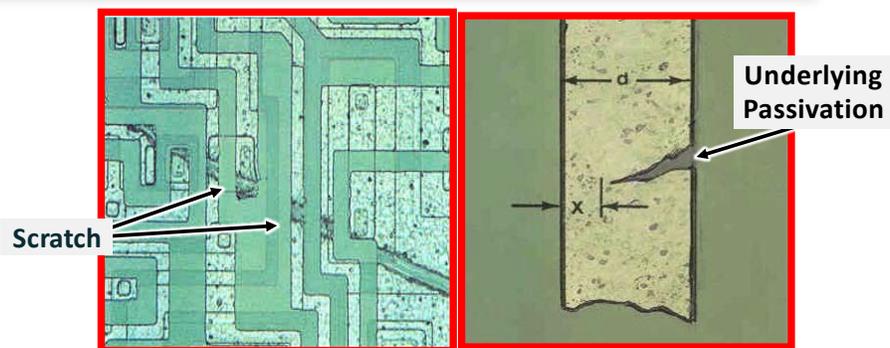
**Class B:** Scratch that exposes underlying passivation anywhere along its length AND leaves < 50% of the original metal width undisturbed.

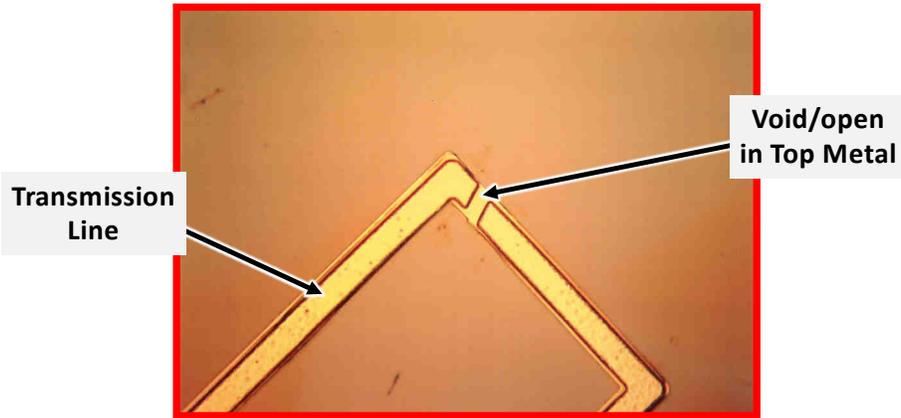
REJECT: Large void in top metal trace. Gold underneath is the sputtered first metal. This defect occurred during wafer fabrication of the MMIC and not due to a tweezer hit or assembly damage. (100X)

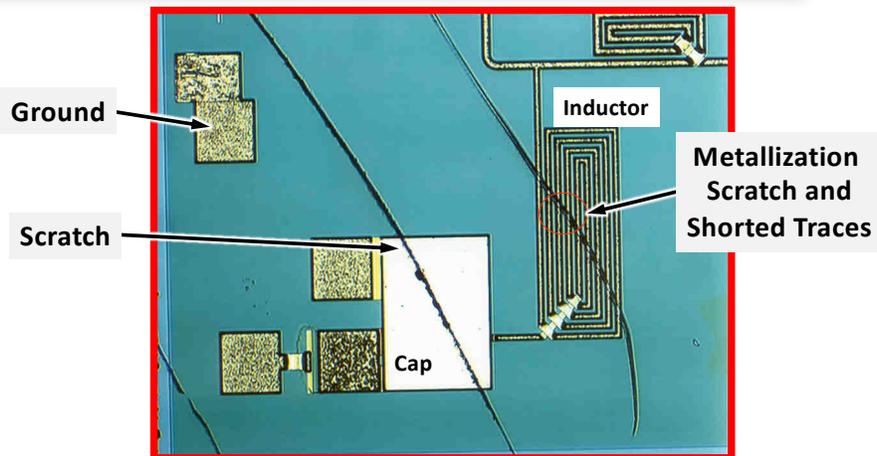
Scratches on surface of a MMIC shows signs of shorting on the inductor. Scratches on the tin fil cap are also cause for concern. (400X)

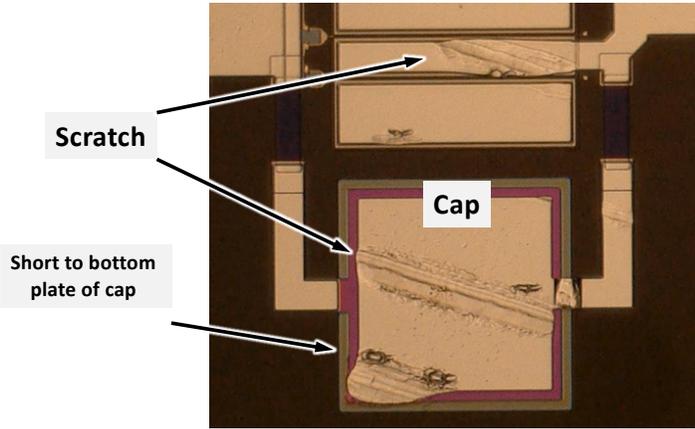
Heavy scratch marks on a capacitor and in the the channel region of the FET above. Scratches or smearing of the gold at the border of a cap will likely cause a short.

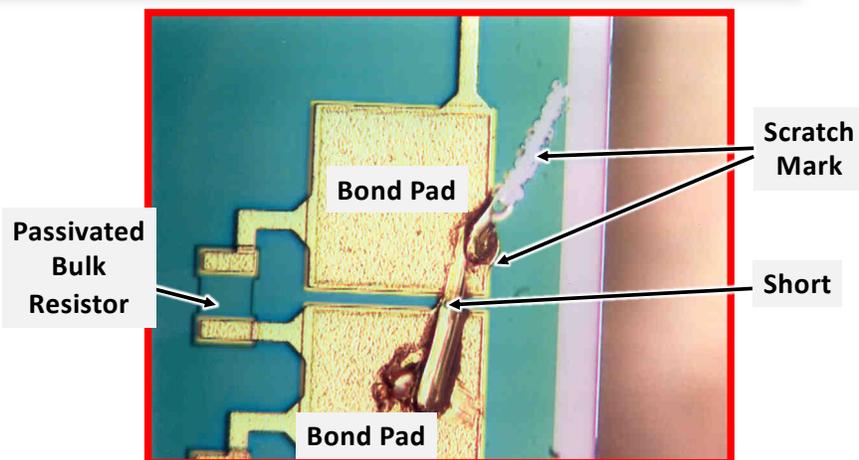
Reject. The resistor is in series, a short across the bond pad will negate the resistor. (200X)

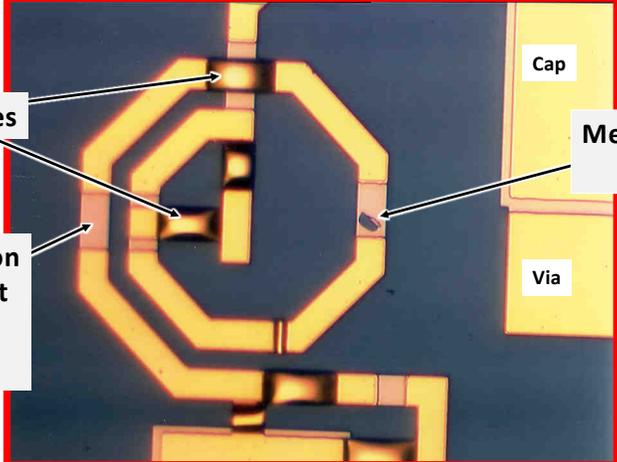
A scanning electron micrograph (SEM) of an RF coupler on a monolithic microwave integrated circuit (MMIC). The coupler consists of several concentric, interlocking metal rings. Several defects are labeled with arrows: 'Air Bridges' between the rings, 'Passivation Over first Metal (Pink)' on the outer ring, 'Metallization Void' in the center of the inner ring, 'Cap' on the right side, and 'Via' at the bottom right.

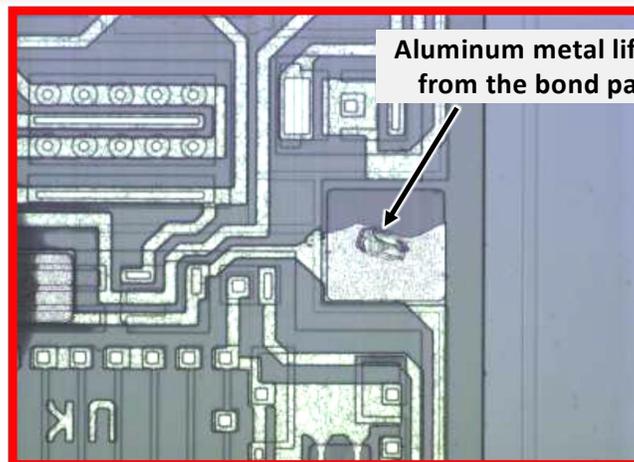
Voiding at the bond pad is a serious problem and in this case the defect was created during wafer fab or probe test.

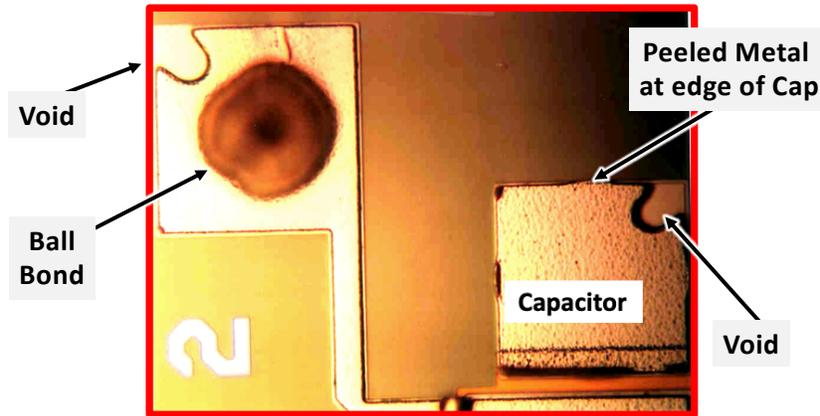
Voiding or evidence of peeling metal at edge of MIM Cap on MMIC is a serious reliability issue. (200X)

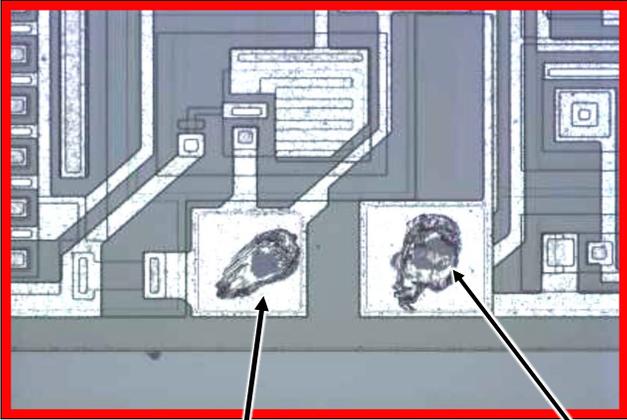
The micrograph shows a bonding pad area with two circular regions highlighted by arrows, indicating excessive probe marks or scratches. The surrounding area shows complex circuitry.

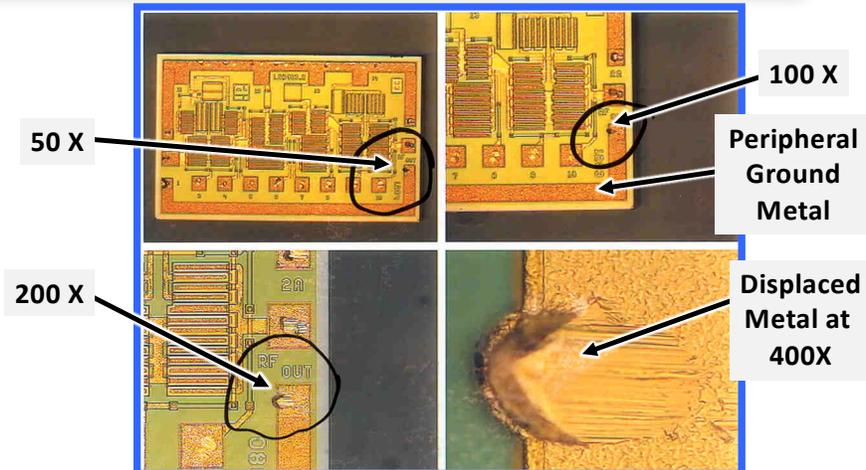
Probe damage causes displaced metal shown at four different magnifications. Not enough to fail the probe damage criteria but potential loose FOD.

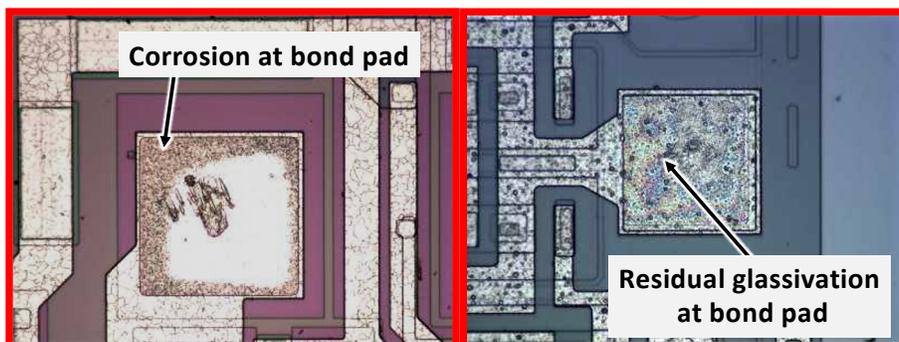
Discoloration and pitting is characteristic of metal corrosion at the aluminum bond pad as shown in pic on the left. Residual glass, that was not properly etched off, will show evidence of color fringing. Corrosion, staining or any discoloration at the bond pads is cause for concern.

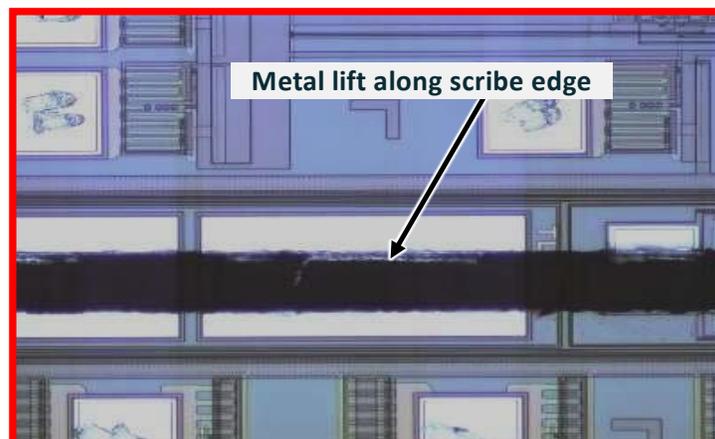
Metallization non-adherence; Any metallization lifting, peeling, or blistering. Above defect probably caused by the wafer sawing process.

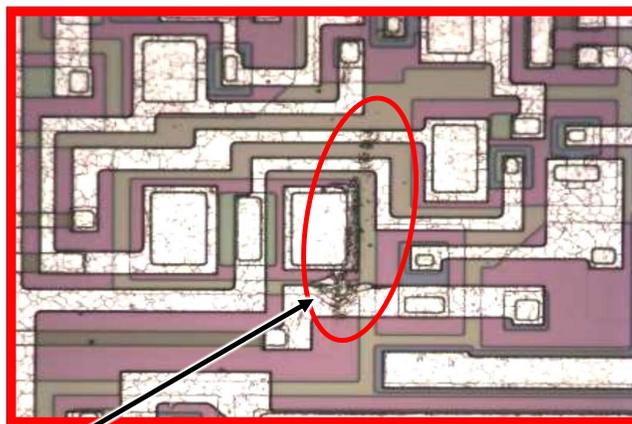
**The metal scratch in this photograph extends across several adjacent metal runs and has pushed or displaced aluminum metal such that it bridges two non-common adjacent metal runs. This metal is disturbed and impossible to rework or repair. (400X)**

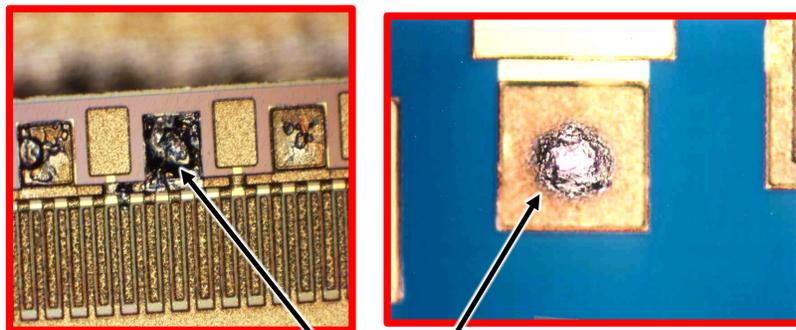
Evidence of solder coming up through via hole pad, occurs when GaAs MMIC die is mounted on a carrier. The ground via is damaged or cracked. Solder from substrate attach should not flow up into the via and break like this at the surface. (100X)

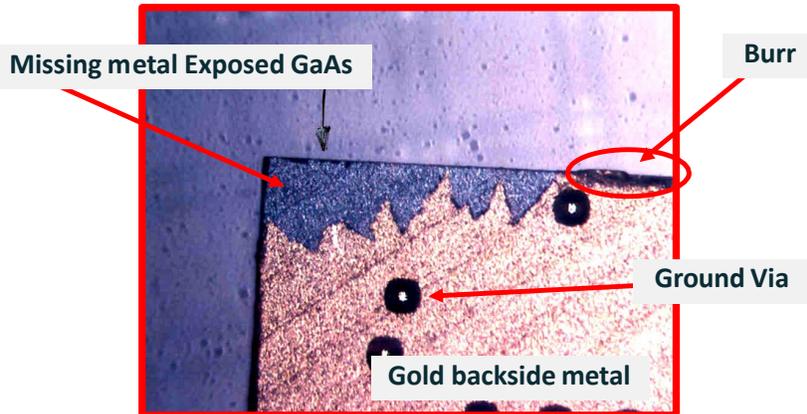
Missing backside metal after saw and break. Possibly pulled off with tape, missing metal such as this may indicate an adhesion problem with the backside metal. We normally don't inspect the backside of a MMIC, but if for some reason it does not lay flat in the wafer back it may be a burr.

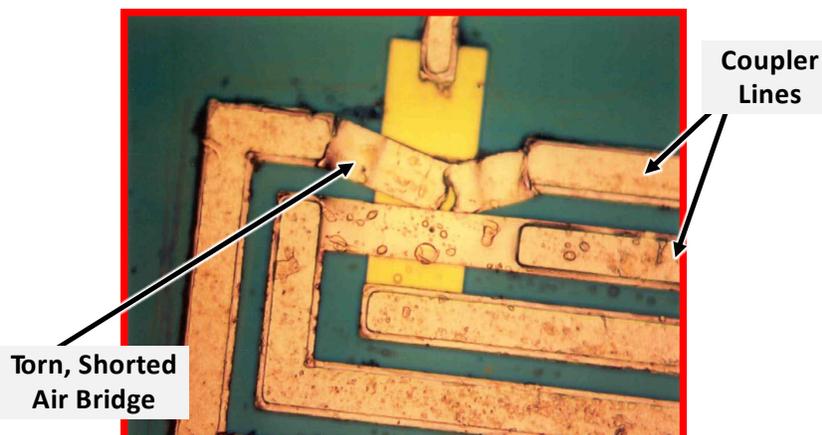
Mechanical damage to an air bridge. In this photo the air bridge is torn and bridging to adjacent metallization. Any tweezer scratch that hits an airbridge would be cause for remove and replace MMIC. (400X)

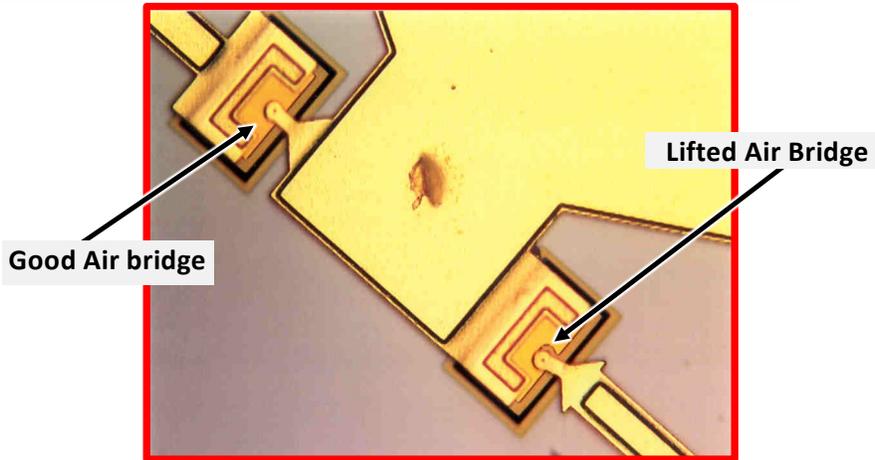
Lifted and shorted air bridge on microwave device. Some defects such as these required magnification levels up to 1000X.

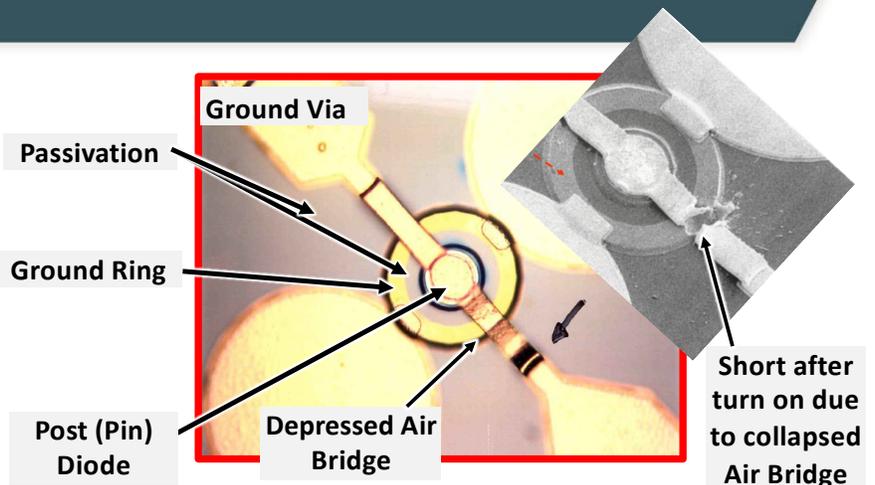
Air bridge appears to be depressed/damaged potential for metal shorting through underside passivation layer. (400X)

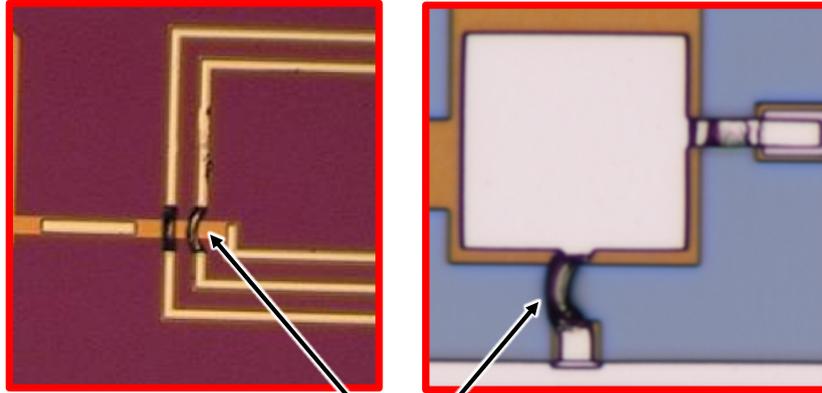
Torn/damaged and/or laterally displaced air bridge structures as shown above are rejects.

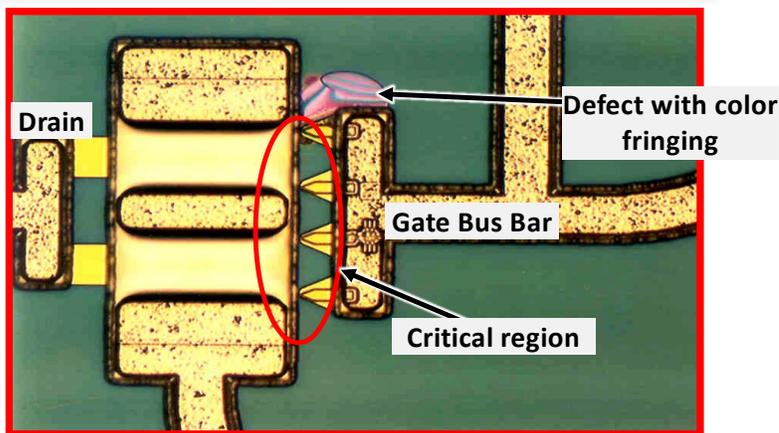
Passivation defect in a critical area. Absence of passivation visible at edge and continuing under the metallization (nitride adhesion) into active circuit area.

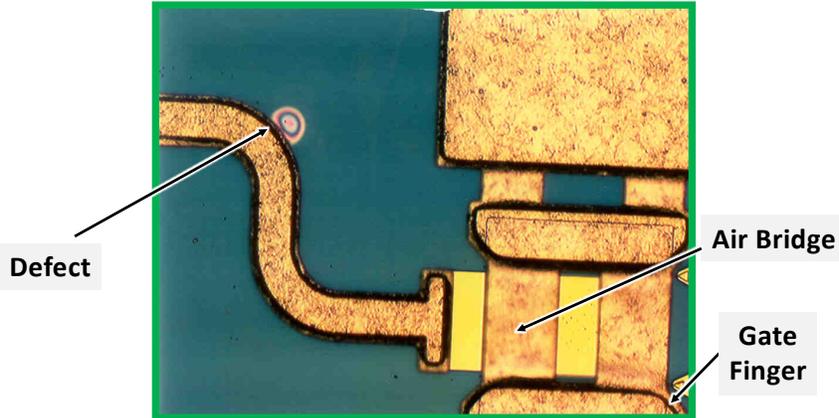
Pic above shows thinning of the passivation next to the transmission line. However, for a MMIC this is OK. Either multiple lines or a complete absence of passivation visible at the edge is normally a reject **unless by design for GaAs devices**. See next slide for further clarification.

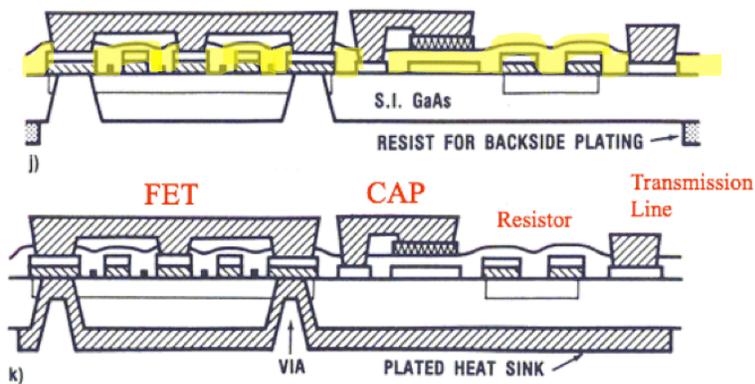
Shown above with the yellow highlight is the silicon nitride field passivation which serves to passivate the resistors, becomes the dielectric for the capacitor and in some cases helps to protect the gate area. Thinning or missing passivation in any of these areas is a REJECT. For metal runs OK to have thinning at the edge of the run or in any non-active area.

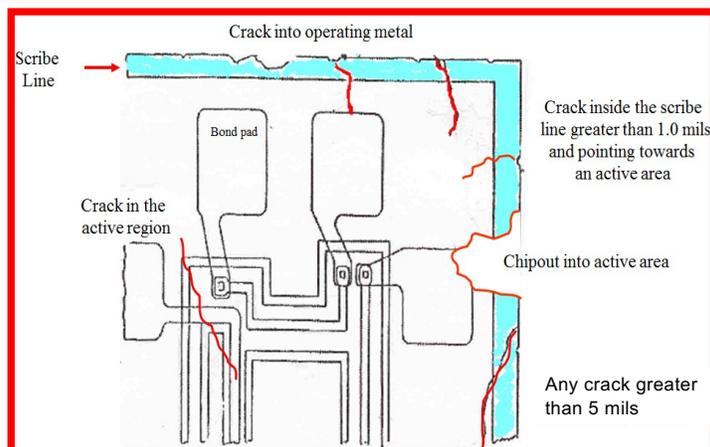
Chips and cracks caused by the wafer saw and/or handling during the assembly process can further propagate in field use or after temp cycling. This graphic is applicable to both MMICs and silicon ICs.

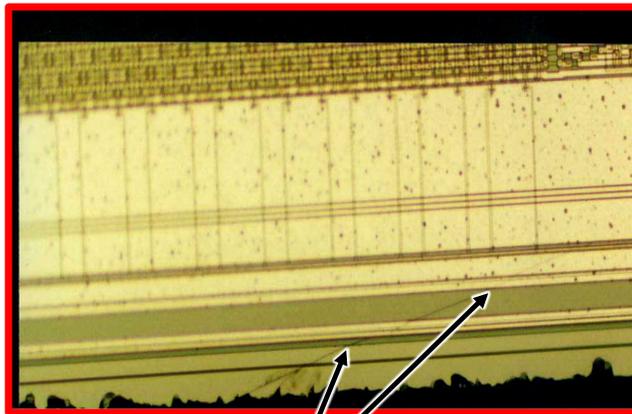
Crack into active area or anywhere on the die greater than 5 mils in length. If possible, it helps to tip the unit and have the reflected light illuminate the crack. Cracks often originate from sharp edge chipouts as shown above.

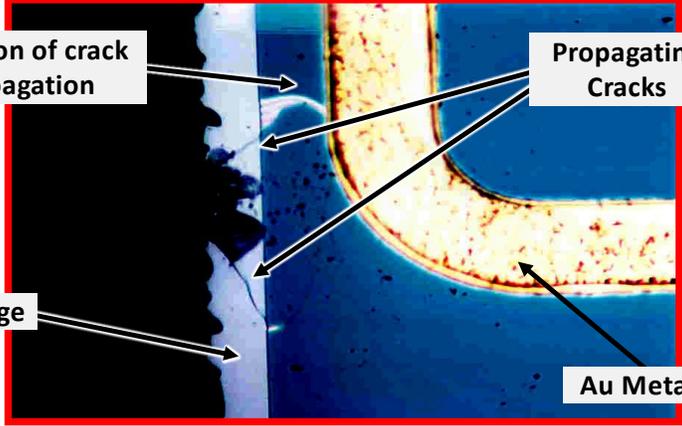
This micrograph shows a die edge on the left and a U-shaped Au metal run on the right. Arrows indicate the direction of crack propagation from the die edge towards the metal run. Labels include 'Direction of crack propagation', 'Die Edge', 'Propagating Cracks', and 'Au Metal Run'.

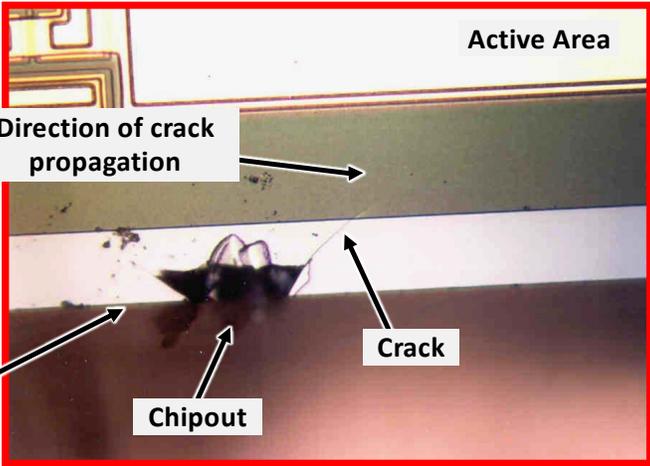
This micrograph shows a chipout at the bottom center with a crack extending upwards towards an active area. Arrows indicate the direction of crack propagation. Labels include 'Active Area', 'Direction of crack propagation', 'Edge', 'Chipout', and 'Crack'.

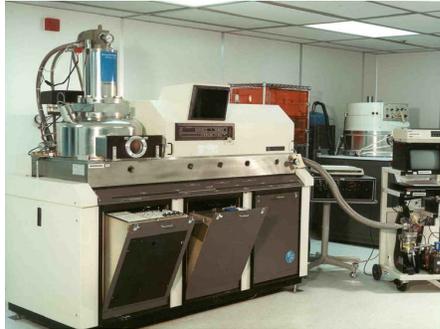
MRC Sputtering System

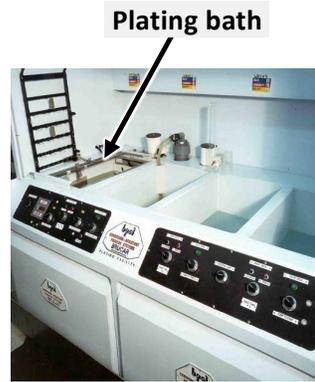
Substrates are sputtered or vapor deposited with a thin film seed layer of metal then electroplated with Ni/Au in a heated bath of plating solution. Typical mil spec plating is 50 microinches of soft gold over 200 microinches of nickel. Tantalum nitride and NiCr are typical resistor materials used in the industry.

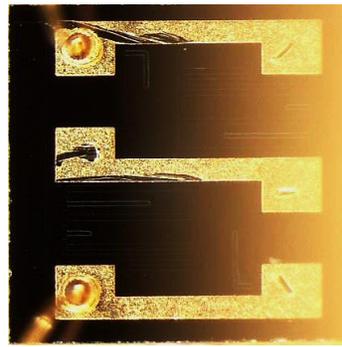
Top Hat Trim

Dark Field

Clean resistor trim into tantalum nitride . . . clean kerf

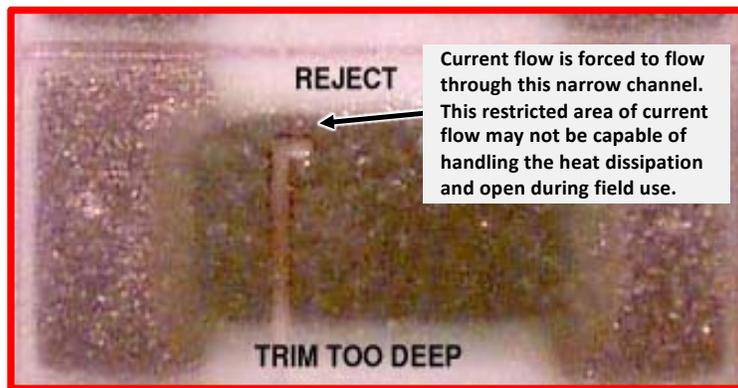
REJECT

Current flow is forced to flow through this narrow channel. This restricted area of current flow may not be capable of handling the heat dissipation and open during field use.

Trim cut is nearly 90% across the width of the printed resistor. Mil specs limit the cut to 50% of the resistor width. The concern is "current crowding" and the potential for an open due to the high current density in the narrow channel as shown at the top.

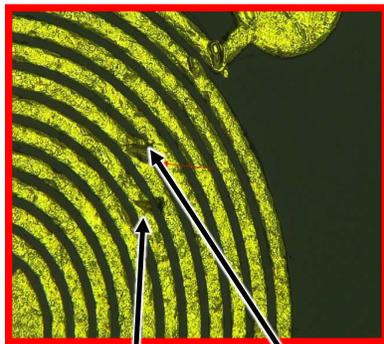
REJECT

Mar in Metal

Metal Protrusion

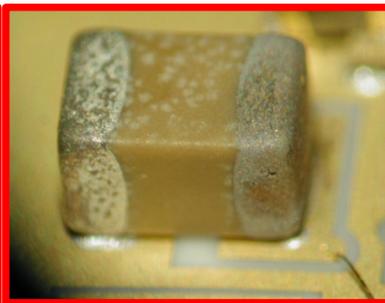
**Capacitor has suspicious contamination**

Part on the left above doesn't sit flat, it's warped. Problems then occur during wirebond when ultrasonic energy is applied to the top surface, thus causing the capacitor to break loose. Part on the right has spotty contamination marks which should be investigated further.

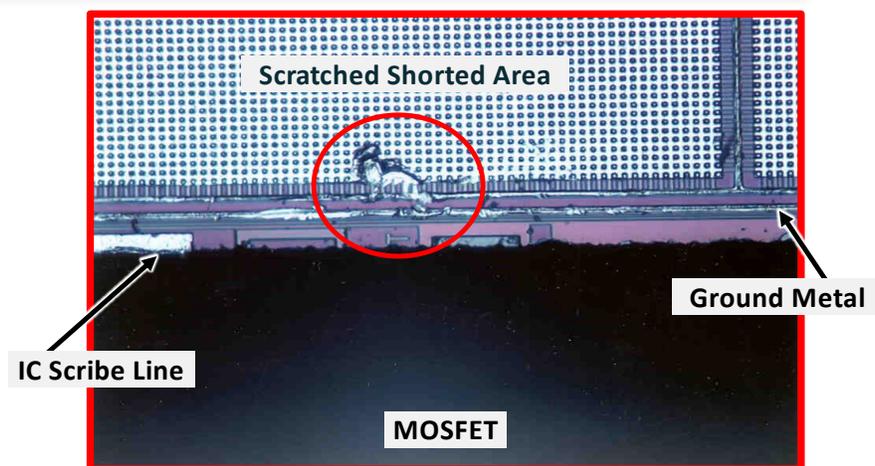
Surface scratch, disturbed metal and shorted. Impossible to rework. (400X)

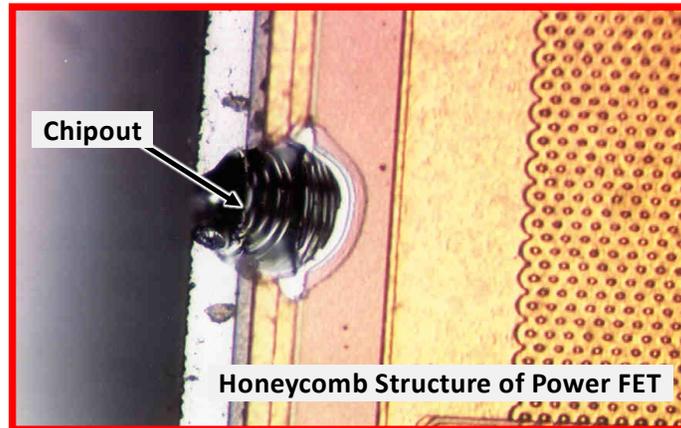
Chipout into active region of the device. On this device the ground metal is also a guard ring. Chipping or cracking into a guard ring is a potential reliability problem.

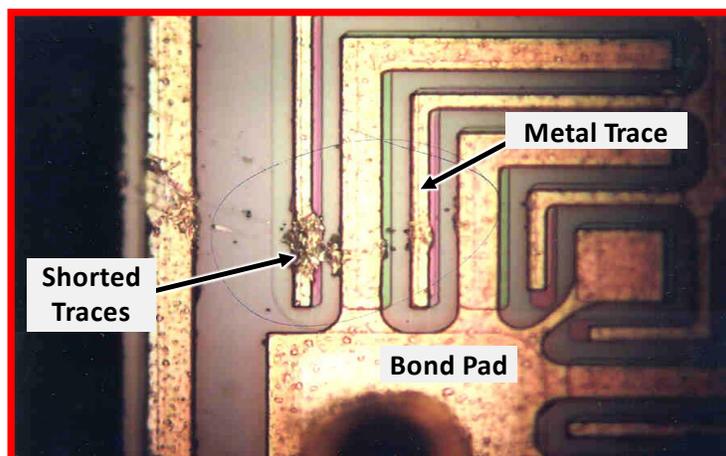
Tweezer damage may have caused this surface scratch creating short between metal traces.

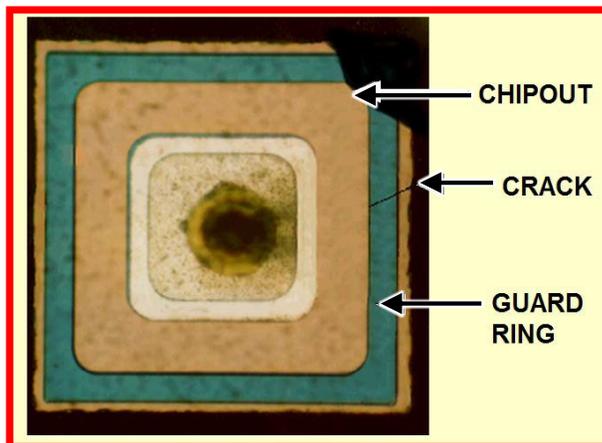
Chipouts and cracks extending into a guard ring are generally cause for reject.

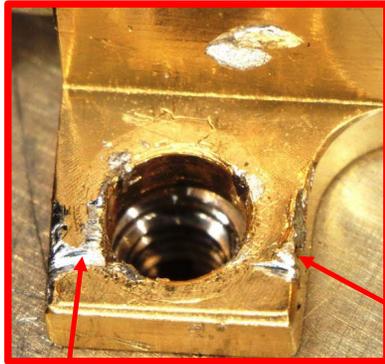
REJECT

Exposed base metal
