# WHITE PAPER

## Silver Epoxy Turns Black after an Oxygen Plasma Clean prior to Wire Bonding ...but so what?

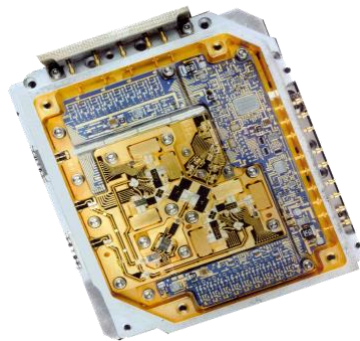
RF Microwave Module
